# STEEL MILL BOILER FAN UPGRADES

**Problem** - Corrosion complications resulting in rotor failure.

**Solution** - Redesign and change in construction material of the rotor.

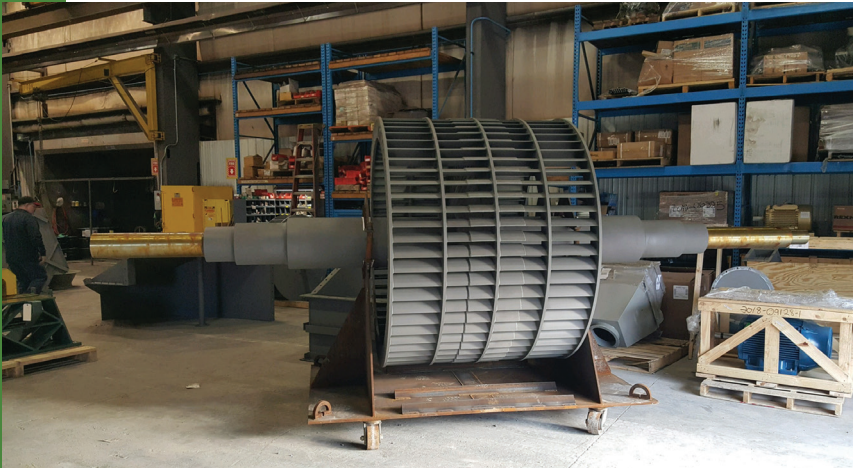
**ID Fan Wheel** - The original wheel was compromised due to corrosion, which eventually led to failure to operate at required capacity. The redesigned wheel was constructed of a more corrosion-resistant material to avoid potential issues in the future.

Bad circumstances can be used to your advantage. A steel mill took advantage of an accident to upgrade the forced draft (FD) and induced draft (ID) fans in one of its power boilers. An ID fan wreck was caused by a combination of problems that resulted in rotor failure. Boiler fuel was a mixture of blast furnace gas and natural gas. An unsuspected economizer leak led to corrosion issues. High Ph from wetted ash started corrosion at weld joints and weakened the forward curved fan rotor. Then, a limit switch failure on the steam turbine governor allowed the turbine to speed up until it reached trip speed. Traditional turbine trip speed is 15 percent above normal operating speed, which

results in a rotor stress level increase of slightly higher than 30 percent. The fan rotor was originally designed to operate safely in the overspeed condition, but the corrosion weakened its welds and it collapsed due to the overload.

Once the cause of the failure was identified, emergency repair was initiated. The casing, dampers, rotor shaft and hub were not in reusable condition. It was also determined the original rotor material was A-36. A design review revealed that an upgrade to A-588 material would provide a nearly 40 percent increase in yield strength and a significant increase in resistance to future corrosion with very little cost difference. Once this was reported, the steel mill decided to implement the upgrade. The mill was also in the process of replacing its existing water-cooled sleeve bearings with split roller bearings, so new bearing pedestals were designed to adapt the new bearings to the existing sole plates.

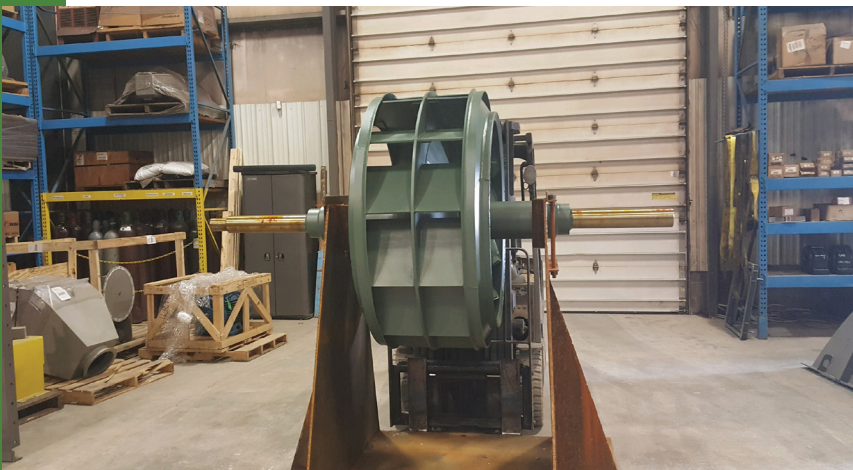
**FD Wheel** - Upgraded material, doubler pads, and new bearing pedestals were some measures taken to ensure this rotor would withstand field conditions.

While the boiler ID fan was being repaired, the FD fan was inspected. This fan was being run overspeed to meet boiler capacity, and signs of blade yield were apparent from the displaced geometry at the blade tip. Once this inspection was complete, stress analysis of the rotor was performed to review its design. Rotor material was upgraded to A-514 to nearly double the material's yield strength. Doubler pads were also added to reduce

high localized stress levels exposed by the analysis. Shaft critical speed was rechecked to make sure the rotor was capable of operating overspeed, and it was determined the existing shaft and hub could be re-used. As with the ID fan, new bearing pedestals were designed to allow the mill to upgrade the FD fan bearings.

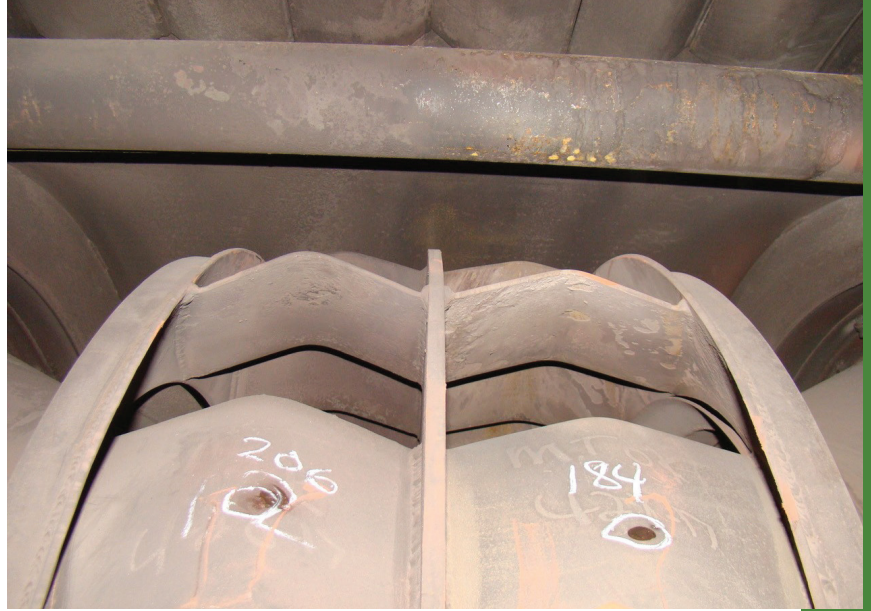
**FD Fan Original** - Most of the components, including this rotor, needed to be redesigned and replaced for the FD fan.
