# STEEL MILL BOILER FAN UPGRADES

SC-340  
R10.20

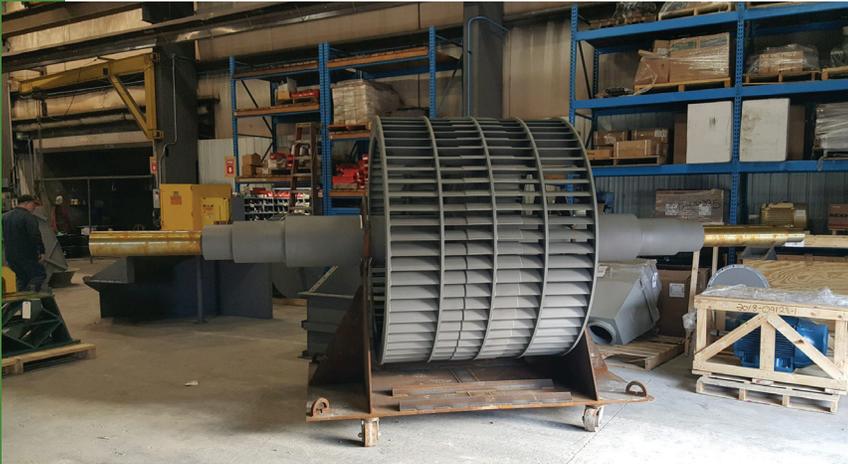
**ID Fan Wheel** - The original wheel was compromised due to corrosion, which eventually led to failure to operate at required capacity. The redesigned wheel was constructed of a more corrosion-resistant material to avoid potential issues in the future.

results in a rotor stress level increase of slightly higher than 30 percent. The fan rotor was originally designed to operate safely in the overspeed condition, but the corrosion weakened its welds and it collapsed due to the overload.

Once the cause of the failure was identified, emergency repair was initiated. The casing, dampers, rotor shaft and hub were not in reusable condition. It was also determined the original rotor material was A-36. A design review revealed that an upgrade to A-588 material would provide a nearly 40 percent increase in yield strength and a significant increase in resistance to future corrosion with very little cost difference. Once this was reported, the steel mill decided to implement the upgrade. The mill was also in the process of replacing its existing water-cooled sleeve bearings with split roller bearings, so new bearing pedestals were designed to adapt the new bearings to the existing sole plates.

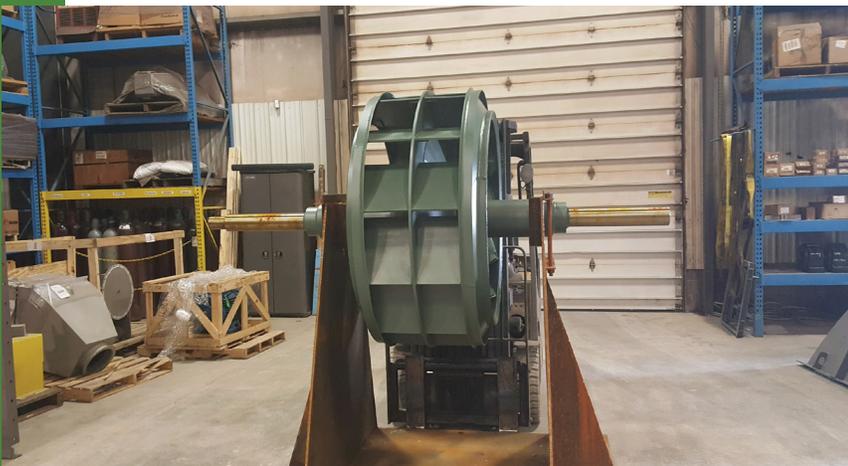
**FD Wheel** - Upgraded material, doubler pads, and new bearing pedestals were some measures taken to ensure this rotor would withstand field conditions.

high localized stress levels exposed by the analysis. Shaft critical speed was rechecked to make sure the rotor was capable of operating overspeed, and it was determined the existing shaft and hub could be re-used. As with the ID fan, new bearing pedestals were designed to allow the mill to upgrade the FD fan bearings.

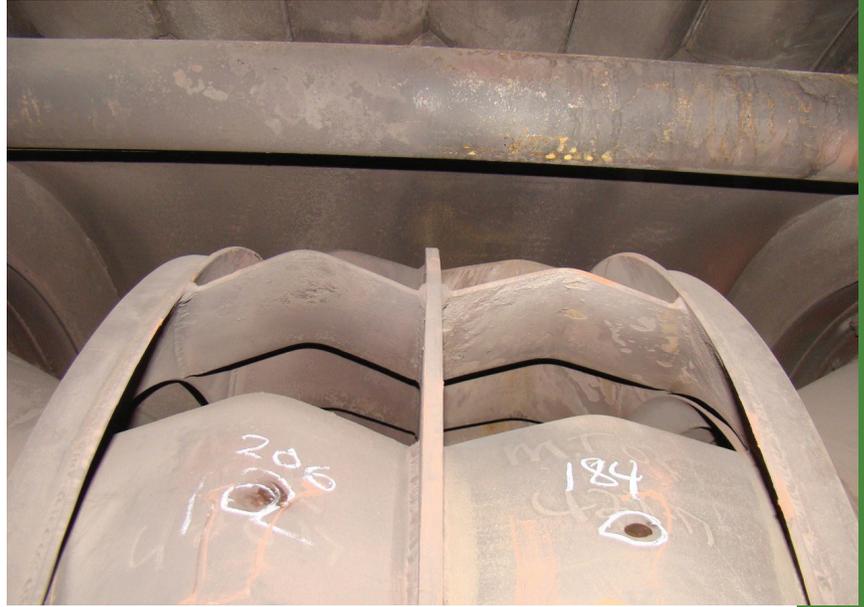
While the boiler ID fan was being repaired, the FD fan was inspected. This fan was being run overspeed to meet boiler capacity, and signs of blade yield were apparent from the displaced geometry at the blade tip. Once this inspection was complete, stress analysis of the rotor was performed to review its design. Rotor material was upgraded to A-514 to nearly double the material's yield strength. Doubler pads were also added to reduce

**FD Fan Original** - Most of the components, including this rotor, needed to be redesigned and replaced for the FD fan.
